A PRELIMINARY INVESTIGATION INTO THE RELATIONSHIP
BETWEEN PLANT HEALTH AND BRANCH LABELLING
TECHNIQUE AT THE ROYAL BOTANIC GARDEN EDINBURGH

Paul Bradley¹ & Robert Cubey²

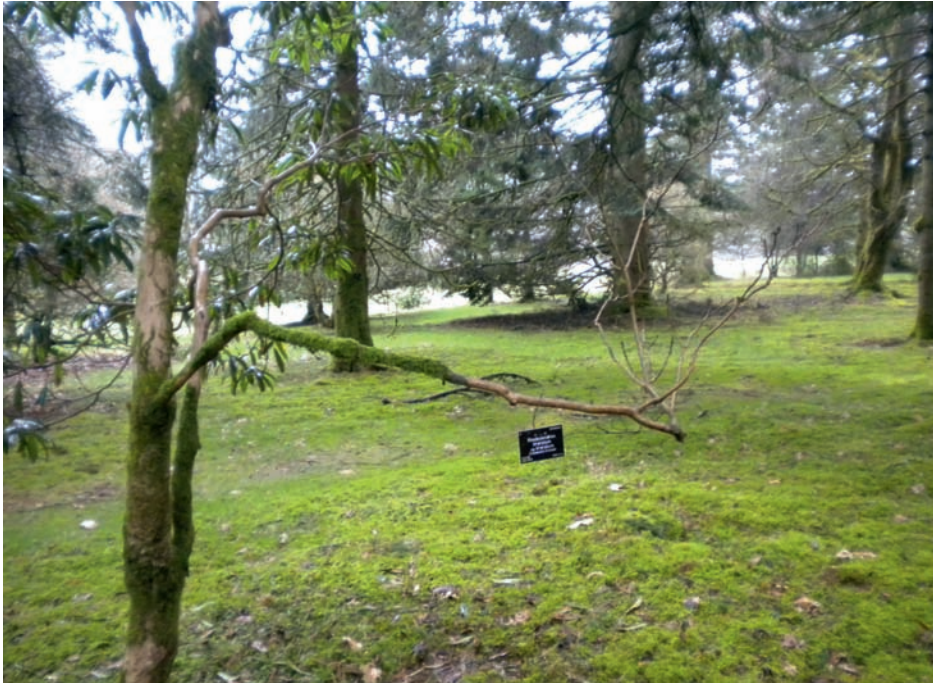
Accidental girdling is easy to diagnose and was not the focus of this investigation. The concern raised was that branch death seemed to occur where loosely attached labels were located (see Fig. 1). One opinion relating to this type of damage was that the force of the wind on a loosely attached label agitates the wire, which eventually cuts through the outer layer of thin-barked species. This effectively girdles the branch without constricting it.

Fig. 1 A healthy specimen of *Rhododendron irroratum* at Benmore Botanic Garden with one dead branch on which the label is attached. Photo: Paul Bradley.

lichens and mosses are more common on the trees and shrubs, it was normal to find the area around the attachment area completely devoid of these (see Fig. 1).

- When deadwooding thin-barked species, staff should not remove dead labelled branches as the next branch used to hang the label may suffer the same fate.
- Labels should be attached to stakes next to thin-barked shrubs and young trees wherever possible rather than attached to the branch. Existing accessions should be altered accordingly.
- Weathered and discoloured wire should be replaced.
- Label wire should be loosened to prevent constriction of branches as part of the stocktaking process.
- Labels should not be attached to the leaders of any trees.

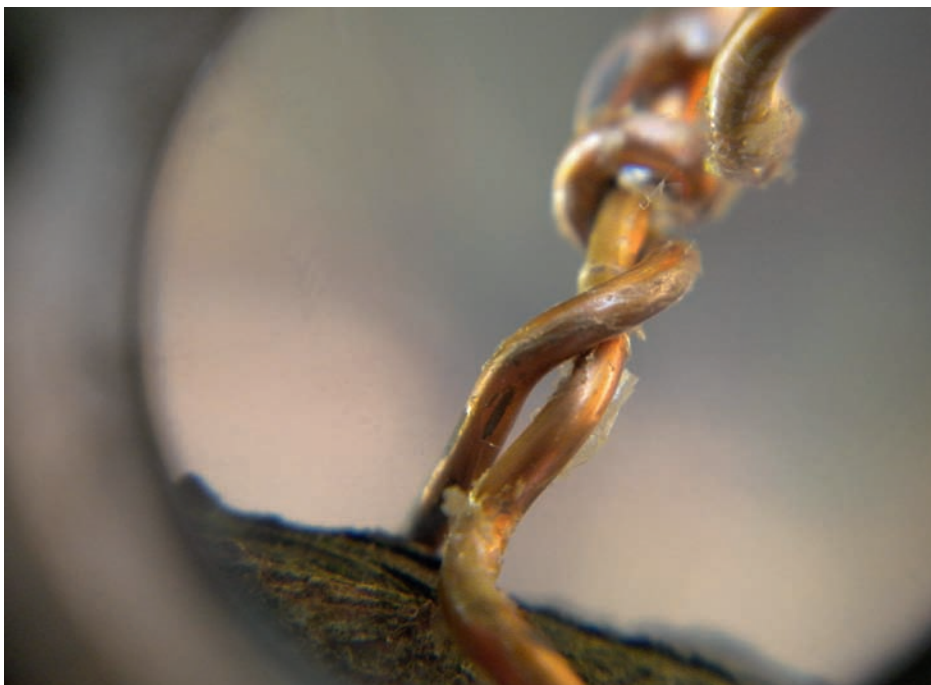
shortcoming with respect to the way it is used at RBGE because it is constantly exposed to high UV levels. Close examination of the wire on the labels of specimens in the Chinese Hillside area at RBGE revealed that the protective coating was flaking off and oxidation was evident on the exposed wire core (see Fig. 2).

Fig. 2 Copper wire showing the protective layer breaking down and flaking off. Photo: Paul Bradley.

The copper wire currently used at RBGE is Magnetemp® CA 200 and the protective coating does break down in UV light, as observed in the Living Collection survey; this corresponds to the findings of a previous study (Alvino, 1971). Acid rain is still evident over Benmore and Edinburgh (Fowler *et al.*, 2004). Once the coating has broken down, acid rain can cause the copper to leach out of the wire.

As a result of these findings it is suggested that plastic-coated galvanised metal wire should be used. It may also be of interest to staff managing resources that it is 58 per cent cheaper than copper wire.

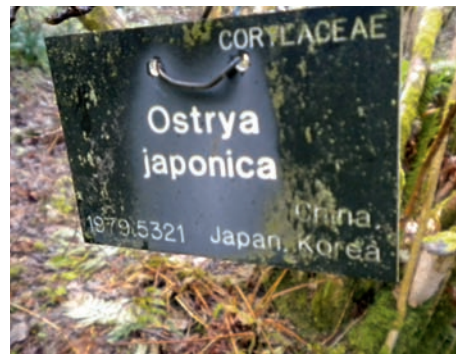
Where the copper wire was discoloured through ageing, bleaching or lightening of the black display label was noticeable around the attachment points and below on the tag face (see Fig. 4).

Fig. 4 Label showing the effects of copper leaching and run-off from weathered wire at Dawyck Botanic Garden. Photo: Paul Bradley.
