# The historic greenhouses of the Greifswald Botanic Garden (Mecklenburg-Western Pomerania, Germany) – rescued in the nick of time

The historic greenhouses of the University of Greifswald, built between 1884 and 1886 and covering an area of almost 300 m<sup>2</sup>, are characterised by their riveted frame construction typical of the era. After almost 130 years of uninterrupted use, they were briefly on the brink of collapse in 2014 because damage caused by corrosion had reached a critical level. The State Monument Preservation Office campaigned strongly for the greenhouses, so that the university, with the support of the State of Mecklenburg-Western Pomerania and other sponsors, was ultimately able to successfully carry out the restoration. The costs are expected to amount to around €4.3 million. The construction work undertaken on the tropical, palm and cycad houses guarantees that valuable plant collections will be preserved and that more extensive growth phenomena and ecological relationships can be demonstrated in the future.

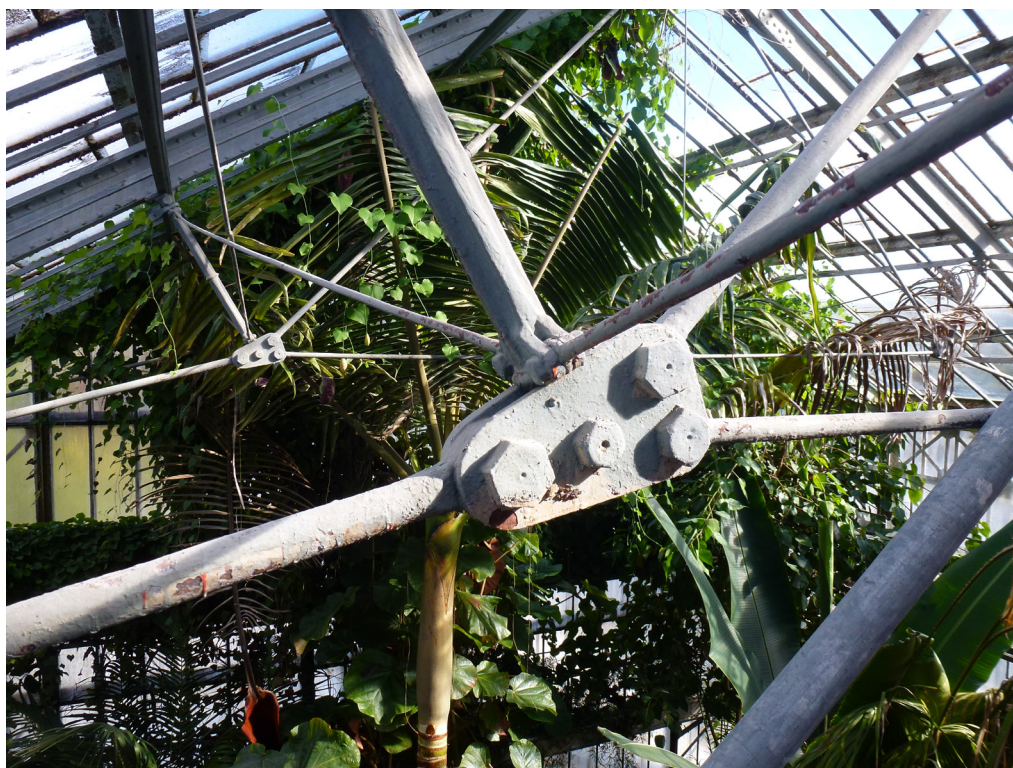
**Fig. 3** Reinforcement bracing developed by two engineers, Wiegmann and Polonceau, in the palm house, the largest greenhouse in the complex with a ridge height of 12 m, before restoration. Photo: P. König.

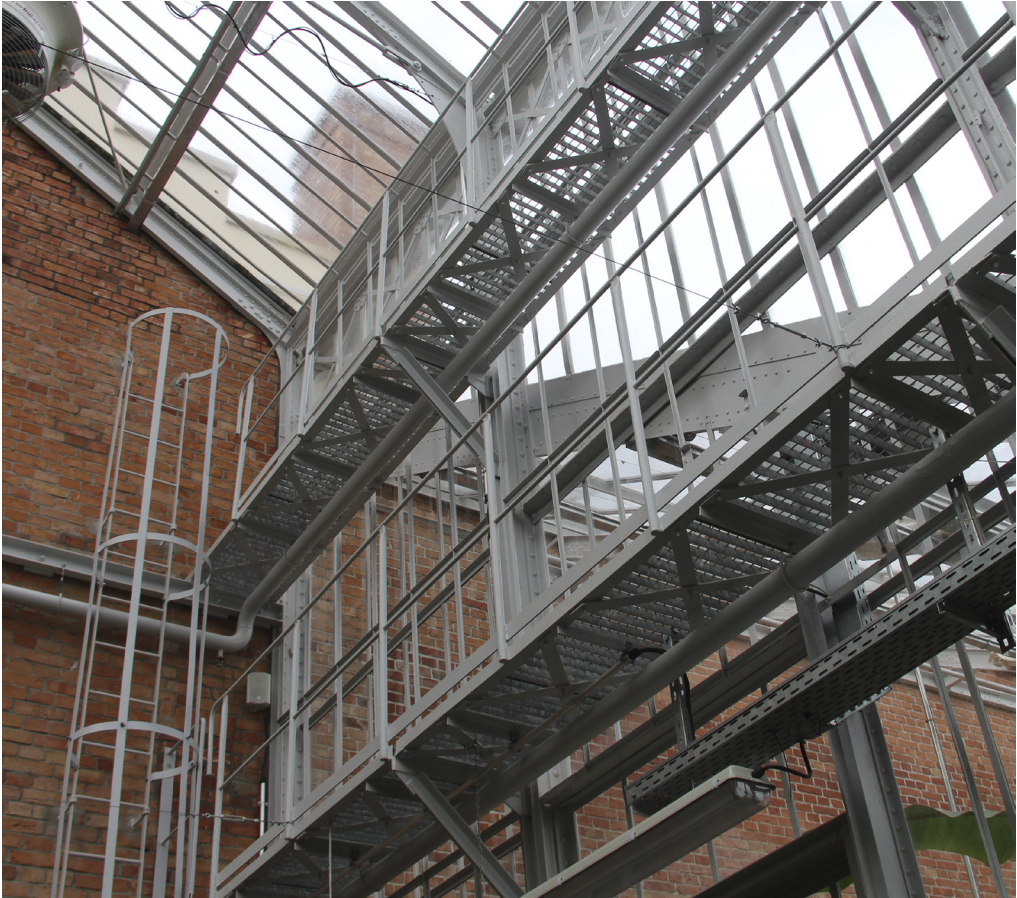
**Fig. 4** Palm house, two U-shaped maintenance galleries with access ladder, after restoration and the addition of a safety cage. Photo: P. König.

- using safety glass for the roofs of the three greenhouses in accordance with overhead glazing regulations
- preparing the existing catwalks with handrails along the ridge lines of all three greenhouses and along the rain gutters of the palm house in accordance with accident prevention regulations and fitting these with additional railings and safety cages. Their present condition no longer meets the current requirements.

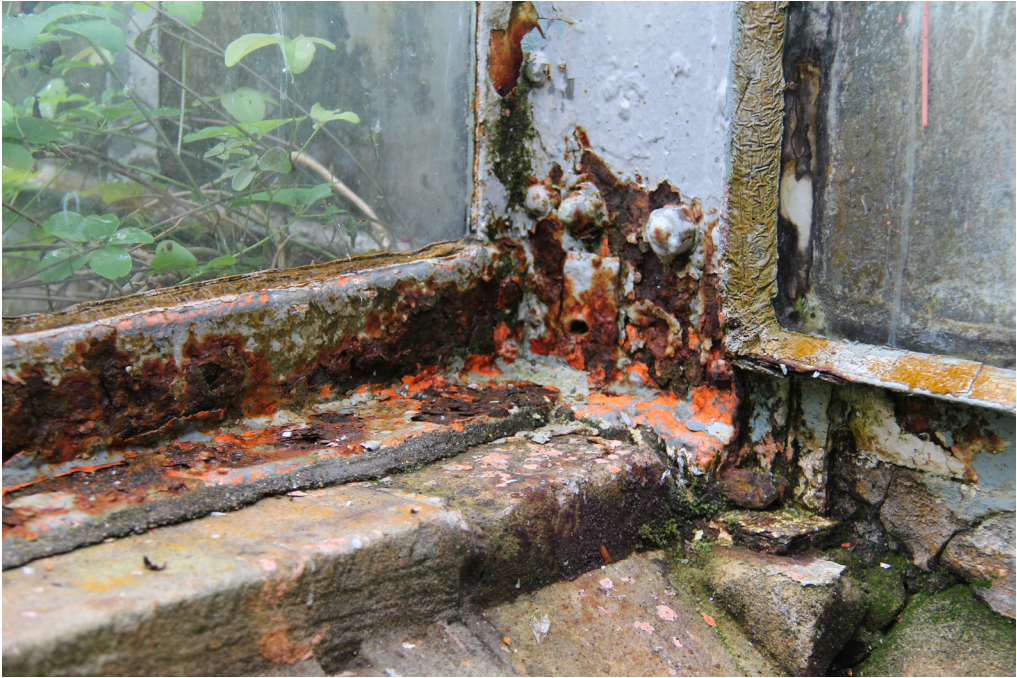
the structurally important elements of the glazing and the bases of the entire steel support structure had rusted severely. During a thorough overhaul and expansion of the greenhouse complex from 1950 onwards (the buildings had been neglected during WWII and the immediate post-war years), the double glazing was replaced by single glazing, because algal growth in the 15 cm gaps was persistent. The comprehensive maintenance measures carried out in the years 1986 to 1990 were able to stop corrosion temporarily, but could not prevent it in the long run. Deglazing, derusting, partially replacing the steel, painting with corrosion protection and finally reglazing were all mainly carried out by the gardeners themselves in addition to their horticultural duties, and the locksmith work with after-hours brigades. Some measures could not be implemented properly. This approach, taken in GDR times, would be unimaginable today. Individual elements were now so severely corroded that their load-bearing capacity was compromised (Fig. 7).

**Fig. 7** Corrosion and rust damage at the base of the frame construction. Photo: P. König.

The system was then completely deglazed and encased in order to sandblast the steel structure. Immediately afterwards, the bare material was coated with an anti-corrosion agent, and successive steel sections that had been destroyed by rust were replaced. Ultimately, more than 90 per cent of the existing historical steel structure was preserved.

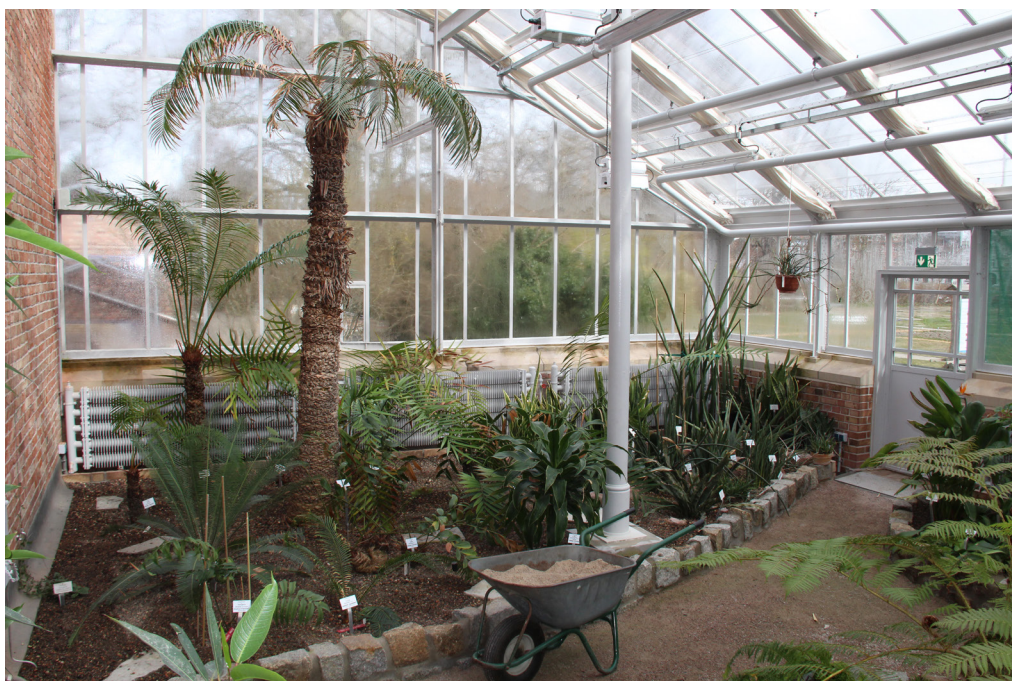
**Fig. 8** The replanted cycad house is home to a 100-year-old female *Cycas circinalis*, weakened since the construction period. The *Sansevieria* collection is located in the right-hand part of the plant bed. The pillar construction typical of the construction period can be seen, as can the old radiators in the background. Photo: P. König.

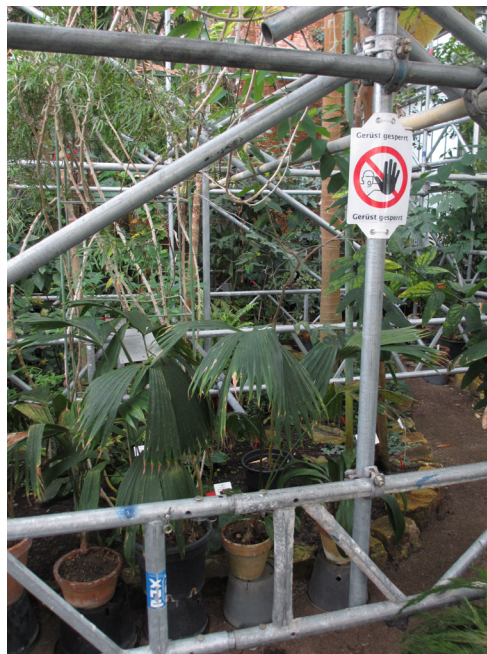
**Fig. 9** The advanced corrosion of the footings in the palm house made bracing with scaffolding elements necessary. Fortunately, garden staff could continue to look after the plants, albeit under difficult conditions and with a few 'gymnastics'. Photo: P. König.

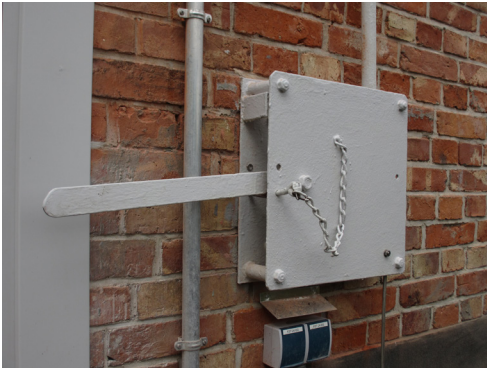
**Fig. 12** The existing lever on a ventilation flap was retained and is fully functional. Photo: P. König.

- to a limited extent, designing ridge-, roof- and standing-wall ventilation flaps with automated shaft drives and toothed racks with modern technology. The existing drives for operating the ventilation windows with a hand crank and cable pull were retained (Fig. 12), allowing an intervention away from the installed temperature- and humidity-controlled computer technology.

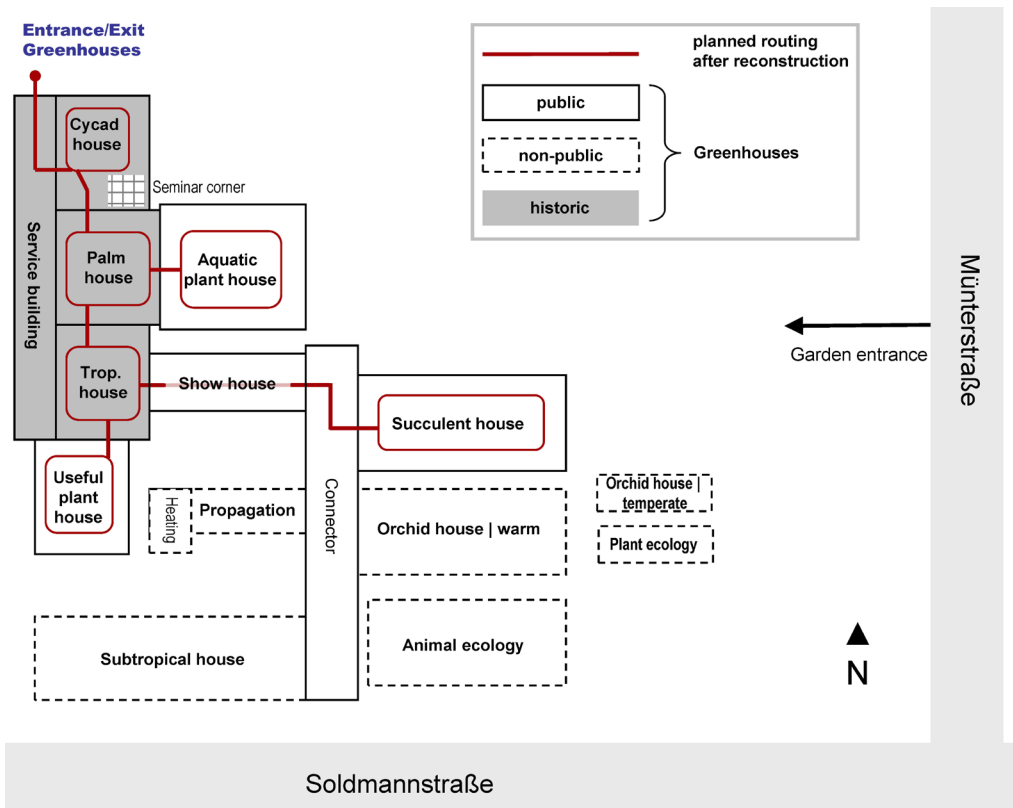
**Fig. 13** Layout of the greenhouses and routing after the reconstruction of the historic buildings. Drawing: P. König.

- relocating the main entrance for easier access from the outdoor area and thermally more favourable transitions (Fig. 13)
- provision of mobile seating in the cycad house (about 20 seats) to enable lessons and lectures close to the object, with demonstration microscopes and projection options

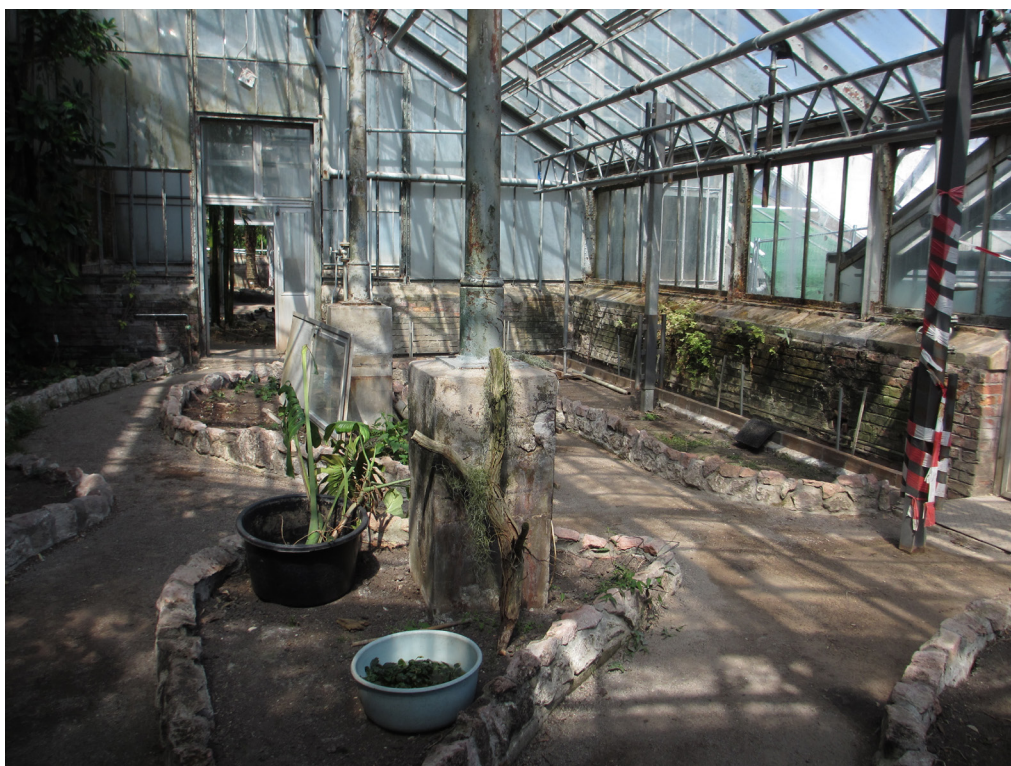
**Fig. 14** Almost-empty tropical house: (centre) the two cast-iron supports; (right) the temporary static reinforcement with scaffolding elements. Photo: P. König.

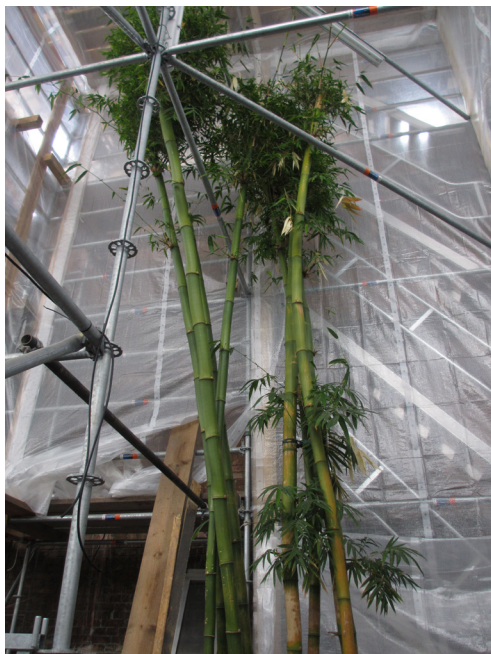
**Fig. 15** *Bambusa vulgaris*, one of seven plants remaining in the greenhouses during the reconstruction work, protected by heated and illuminated polyethylene enclosures. The massive bamboo probably dates back to the early days of the greenhouses. Photo: P. König.

*pubescens* (from Halle Botanic Garden, 1955), *Cycas circinalis* (from Saigon Botanic Garden, 1931), *Ficus cyathistipula* with aerial roots (planted in 1988/1989 at a height of 2–3 m), *Ficus religiosa* (from Thailand, 1984, planted out in 1986), *Gnetum gnemon* (from Dresden Botanic Garden, 1982, planted out in 1988) and *Musa acuminata* (from before 1963). The original location names were given in the accession books from the time. They were housed separately during the reconstruction work and provided with lighting and temperature control (Fig. 15).

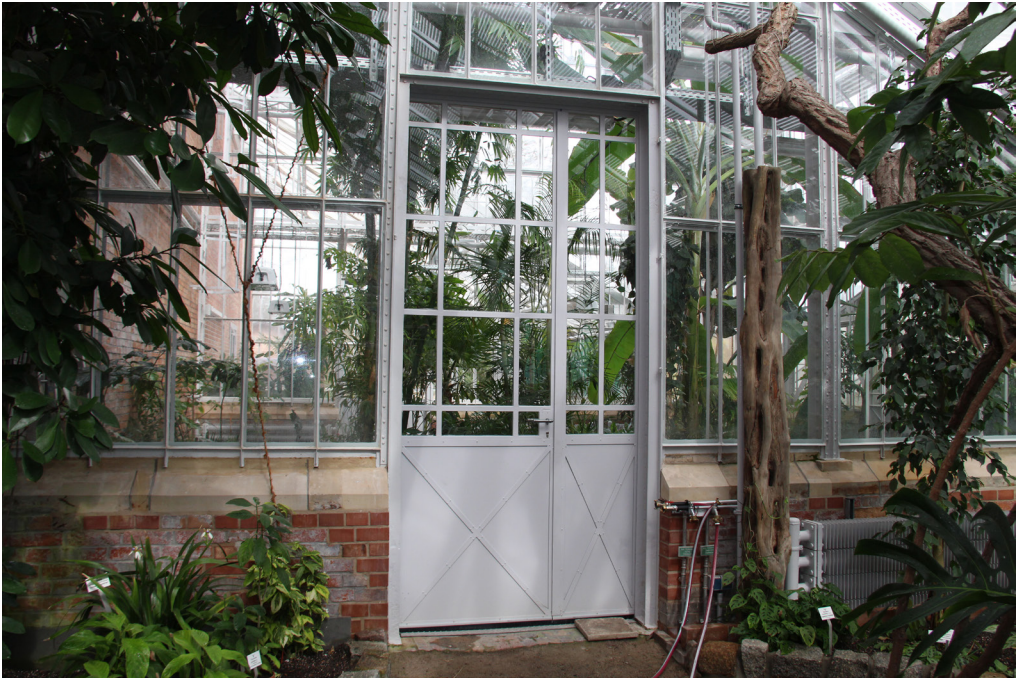
**Fig. 16** View from the tropical house towards the palm house after renovation, with planting not yet complete: (right) trunk which would be used to display epiphytes; (bottom right) the old radiators. Photo: P. König.

As a result, special 8.76 mm thick laminated safety glass in the roof area with a high ultraviolet transmittance of  $T_{UV} = 0.68$  and a light transmittance of  $T_v = 0.90$  was selected, and for the standing walls, a 4 mm

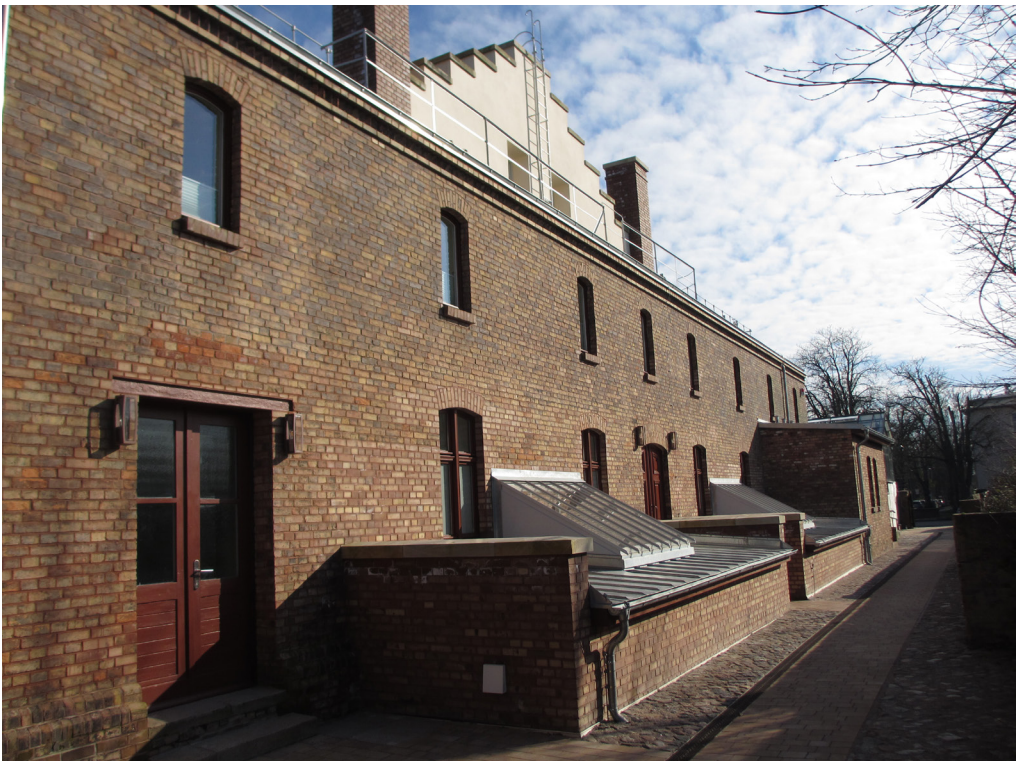
**Fig. 17** West view of the service building after the reconstruction. The hatches, which are now glazed, were formerly used as coal chutes. The gable of the palm house can be seen in the upper part of the photo. Photo: P. König.

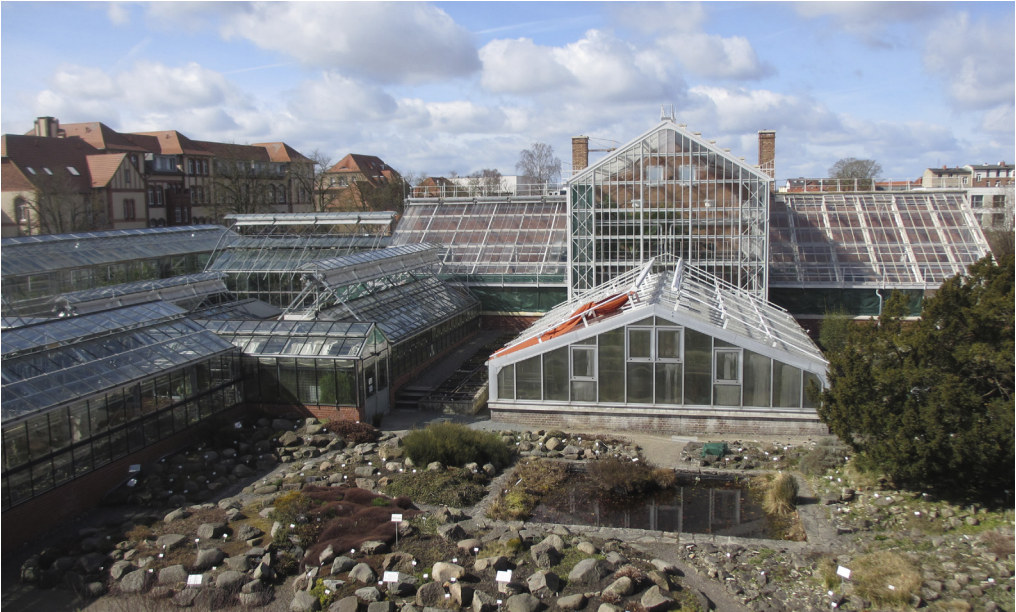
**Fig. 18** A 2022 view of the greenhouse complex with the renewed historical section (two rebuilt chimneys). The aquatic plant house (erected in 1960, overhauled in 1997) is in the foreground, with the show house, succulent house and other greenhouses (1950s to 1962, demolished and rebuilt in 2010–2012) on the left. Photo: P. König.
