Hydrological and planting design of an experimental raingarden at the Royal Botanic Garden Edinburgh

Abstract

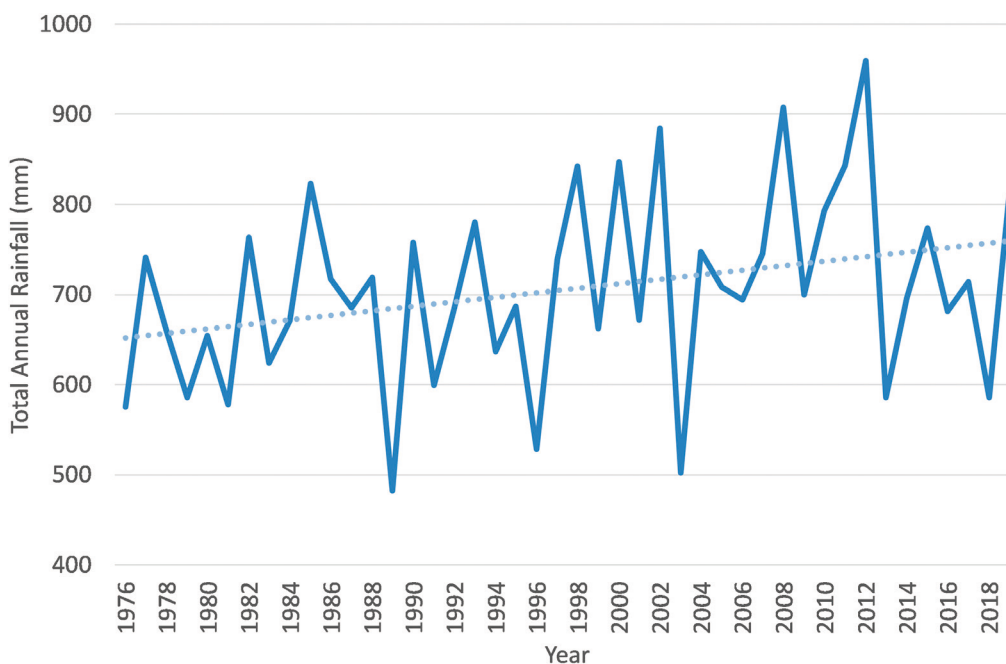
Fig. 1 Total annual rainfall recorded at RBGE (1976–2019) illustrating both the annual variability and the increasing trend.

Observations of recorded rainfall events at RBGE reflect an increased frequency and severity of intense events, with an overall upward trend of annual rainfall. This can be seen in Fig. 1, which presents the total annual rainfall recorded by the RBGE weather station (an official Met Office weather station) from 1976 until 2019. Whilst the natural variability of annual rainfall can be clearly seen, ranging from a low of 483 mm in 1989 to a high of 960 mm in 2012, there is a trend of increasing annual rainfall overall.

Looking at extreme rainfall events more closely, 2012 was the wettest year on record, with total rainfall of 960 mm,

1.36 times more than the long-term annual average rainfall (706 mm, calculated as the average annual rainfall from 1976 to 2019). The wettest month at RBGE was August 2008, which saw 202 mm of rain (3.16 times more than the average for August – 64 mm), followed by July 2012 with 182 mm of rain (2.73 times more than the average for July – 67 mm) and June 2017 with 181 mm of rain (2.89 times more than the average for June – 63mm). In fact, the summer seasons (from June to August) of those years have been the wettest on record at RBGE, with summer 2012 the wettest (410 mm of rain), followed by summer 2008 (367 mm) and summer 2017 (344 mm). The wettest winter season (from December to February) was 2015/2016 with 360 mm of rain falling during those three months. Winter 2015/2016 was also the wettest recorded for Scotland and the second-wettest for the UK, beaten only by winter 2013/2014 (Met Office, 2019a). The wettest day recorded at RBGE was 26 July 1985 with 82 mm of rain over a 24-hour period.

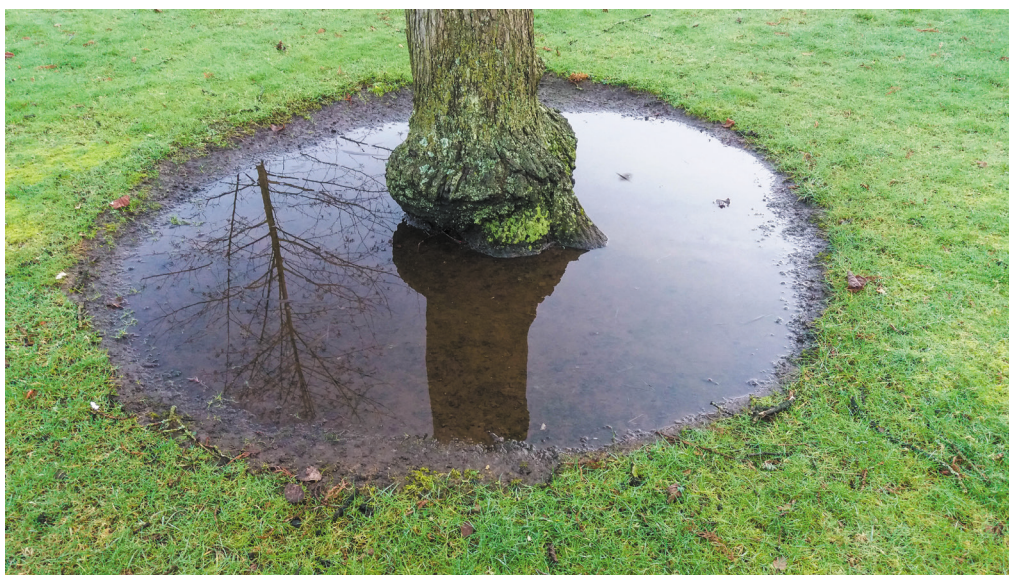
Fig. 2 Tree roots submerged following heavy rain in February 2017. Photo: David Knott, RBGE.

The impact of heavy rainfall events has caused a number of problems across the Garden, including waterlogging and localised flooding. These problems have caused damage to plant beds, lawns and footpaths, and has impacted staff and visitor access due to the closure of affected areas. Figs 2–4 show instances when heavy rain has caused waterlogging of lawns and the submersion of tree and shrub roots – with potential consequences for plant health. Waterlogging of lawns has also affected garden maintenance, making grass cutting difficult and causing soil compaction.

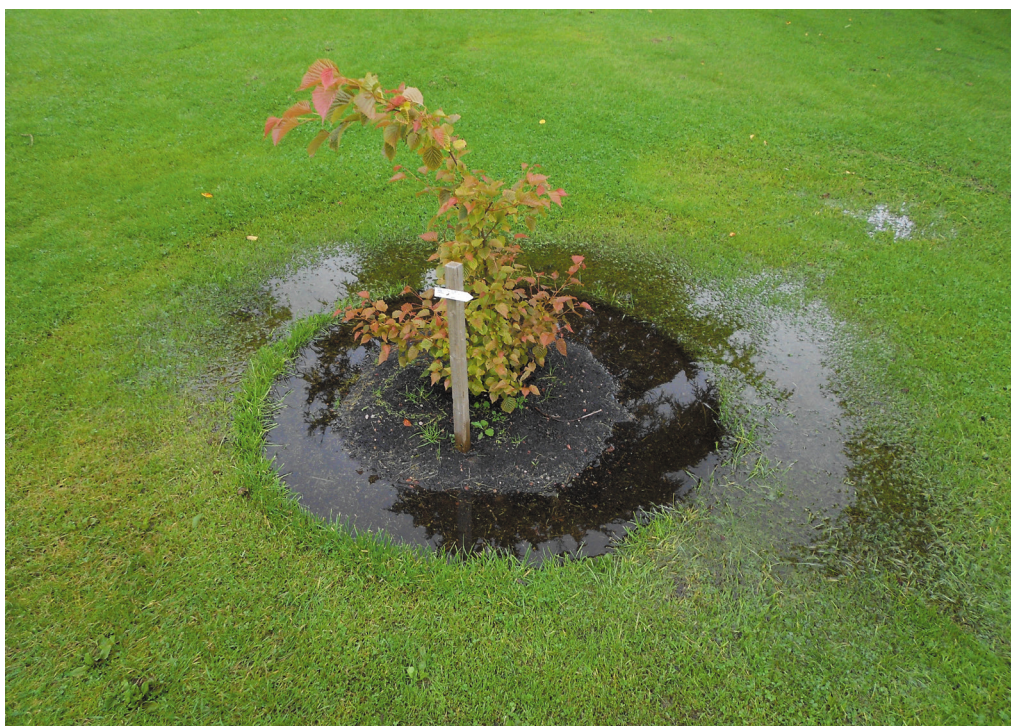
Fig. 3 Shrub roots submerged following heavy rain in February 2017. Photo: David Knott, RBGE.

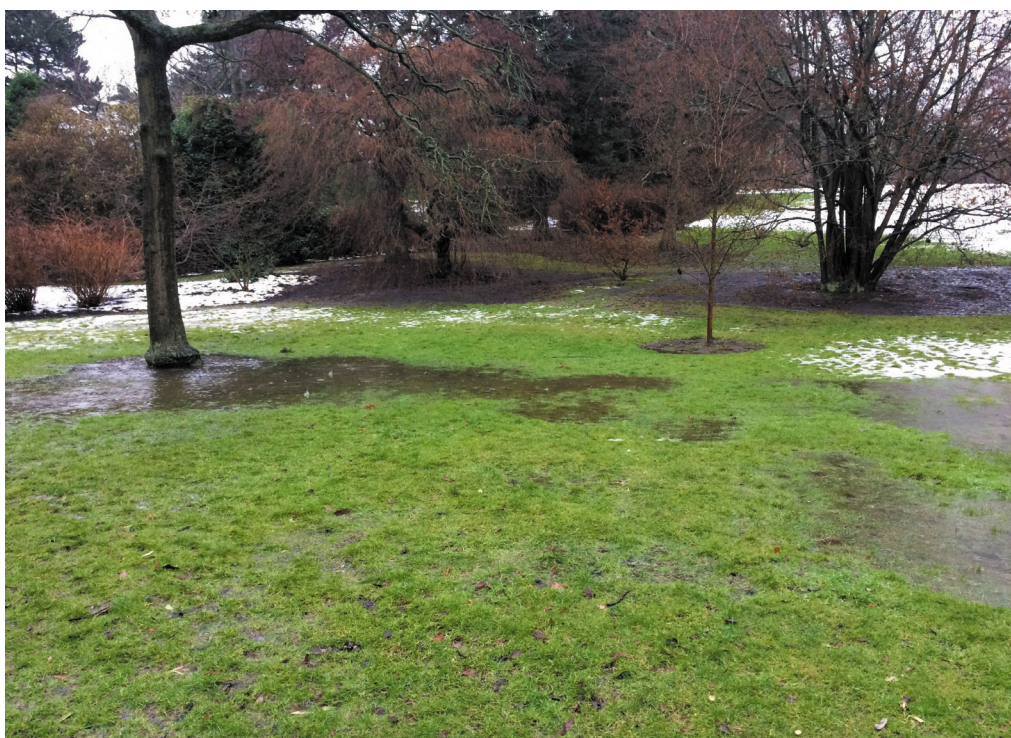
Fig. 4 Waterlogging and root submersion following heavy rain and snow in May 2018. Photo: Leonie Alexander, RBGE.

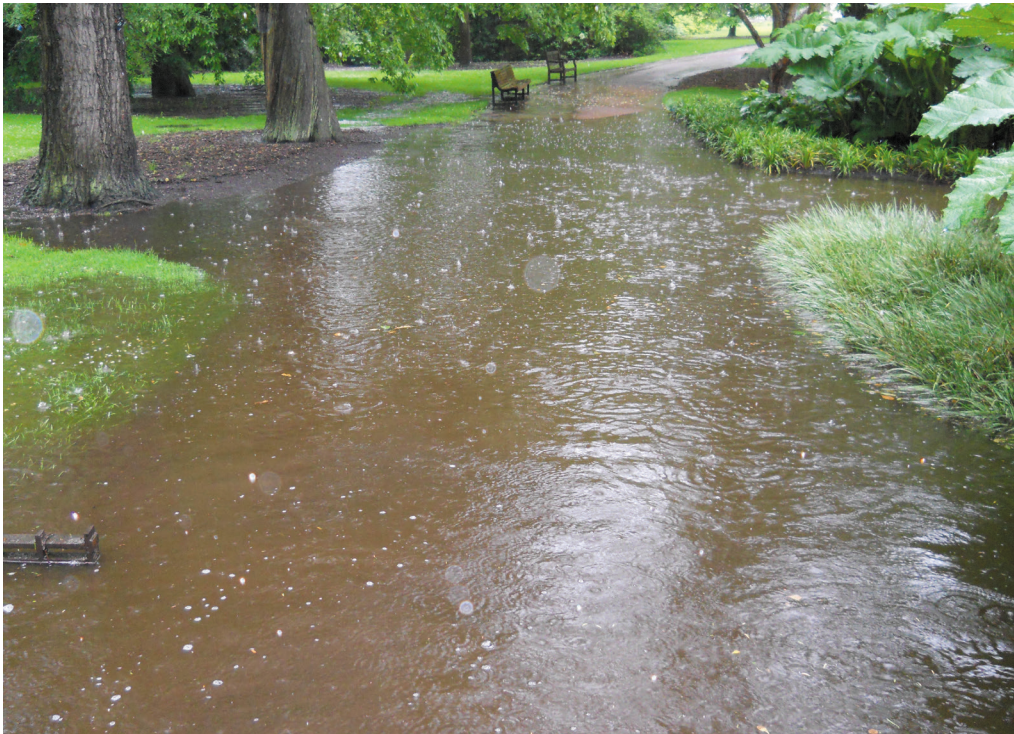
Fig. 5 A section of a main footpath flooded following heavy rain in July 2017. Photo: John Mitchell, RBGE.

The impact of more extreme rainfall events can be seen in Figs 5 and 6; extensive localised flooding occurred in July 2012 (the second-wettest month on record), submerging and blocking a main footpath. After such events, remedial work has been necessary to repair the footpaths and plant beds where soil and surface materials have been washed away.

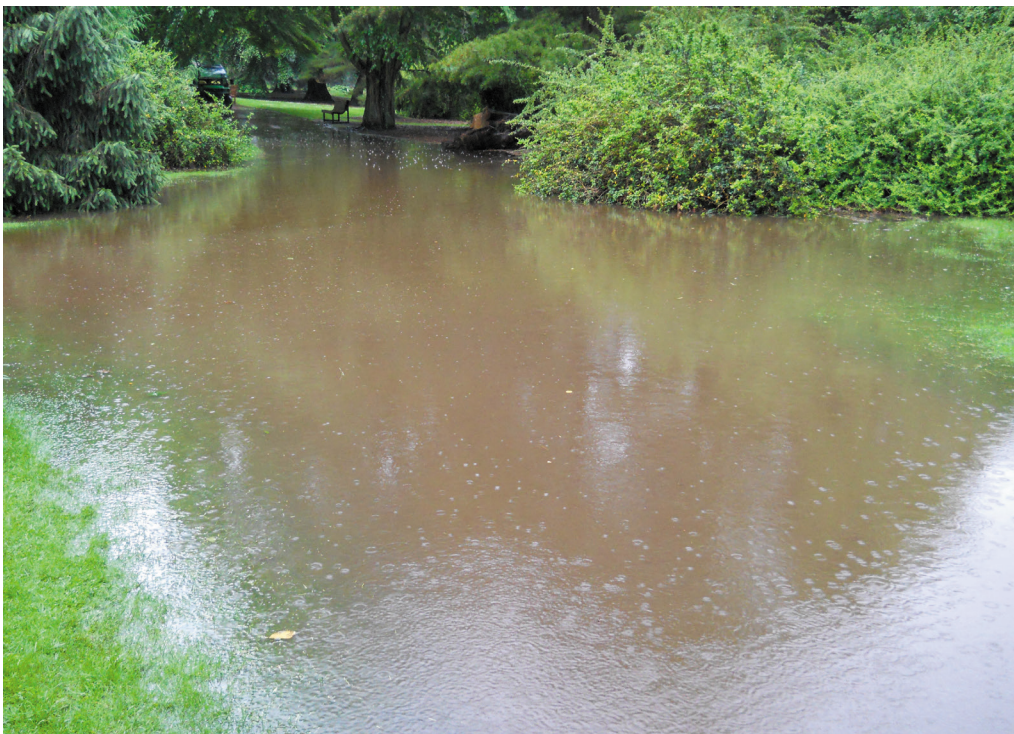
Fig. 6 Further flooding of a main footpath following heavy rain in July 2017. Photo: John Mitchell, RBGE.

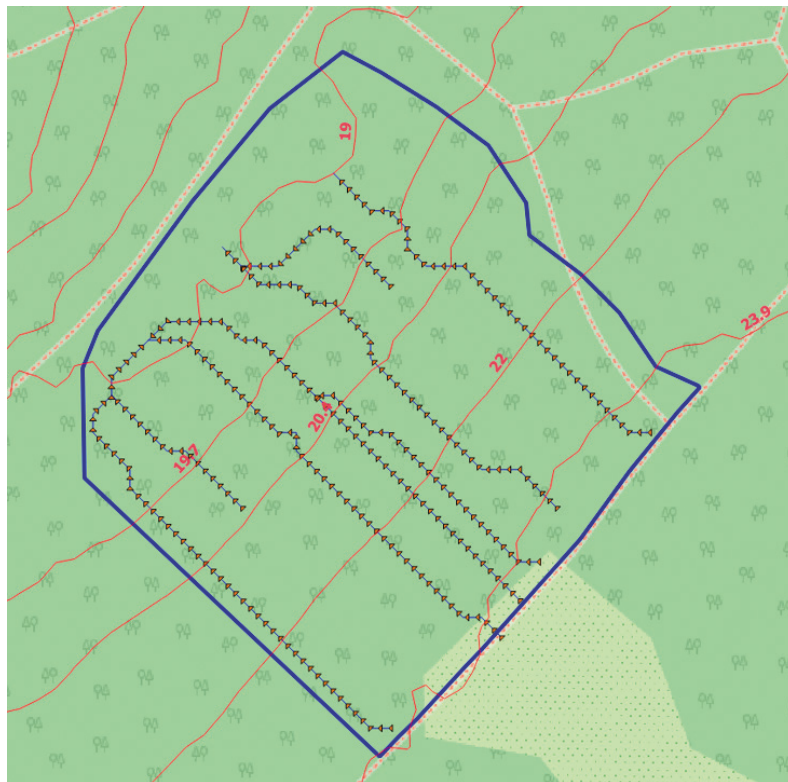
Fig. 8 Rainwater runoff routing at the Birch Lawn as generated by the DTM, QGIS.

Fig. 8 shows the rainwater runoff routing at the Birch Lawn. Assessment showed that the rainwater drainage routes slope at a steep fall of 1 in 10 and culminate at the footpath adjacent to the Birch Lawn. The red contour lines indicate a change in elevation of almost 5 m from the highest point (23.9 m) to the lowest point (19 m) over a length of 50 m.

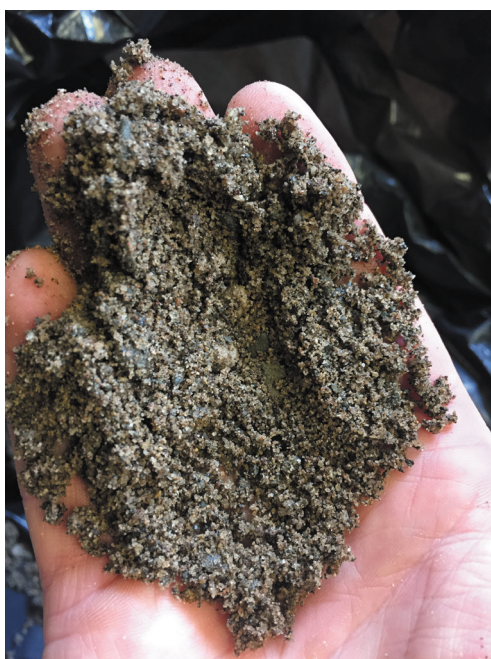
Fig. 9 A sample of the sand used in the amended raingarden soil. The sand had a particle range size of 0.06 to 2 mm. Photo: David Kelly, Heriot-Watt University.

To ensure the raingarden has the ability to intercept, hold and absorb rainfall, the soil within it was amended to provide enhanced infiltration and absorption capabilities. The existing soil was mixed with compost made on site, and sand and gravel to specified particle range sizes and proportions. Figs 9 and 10 show samples of the selected sand and gravel, respectively. The composition of the soil was specifically

20 years. For this study, two compositions of amended soil are being trialled in the raingarden to assess the long-term impact of soil composition on plant health: (i) 30 per cent existing soil, 45 per cent sand, 10 per cent gravel and 15 per cent compost – as suggested in *The SuDS Manual* (Woods-Ballard *et al.*, 2015); and (ii) 45 per cent existing soil, 35 per cent sand, 8 per cent gravel and 12 per cent compost.

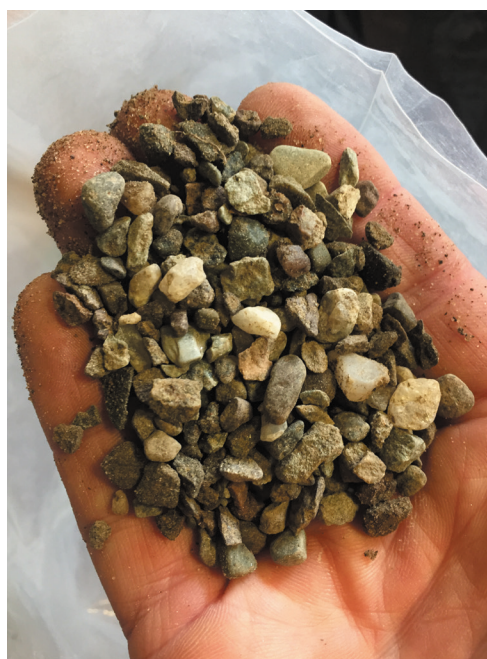
Fig. 10 A sample of the gravel used in the amended raingarden soil. The gravel had a particle range size of 2 to 6 mm. Photo: David Kelly, Heriot-Watt University.

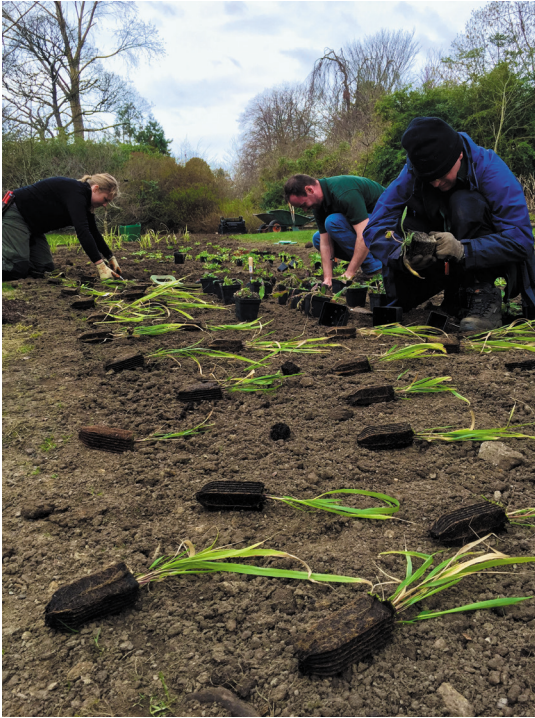
Fig. 14 Members of the horticulture team lay out the young plants before planting into the amended soil of the raingarden. Photo: David Kelly, Heriot-Watt University.

Planting of the raingarden took place in March 2019. Fig. 14 shows this in progress with members of the horticulture team having laid out the young plants ready for planting. Once complete, a layer of gravel was spread over the bioretention area of the raingarden and organic mulch was added to the surrounding area. These gravel and mulch layers were used to help retain soil moisture during dry periods, whilst also helping to protect the amended soil from erosion, aid plant establishment and reduce maintenance by suppressing weeds.

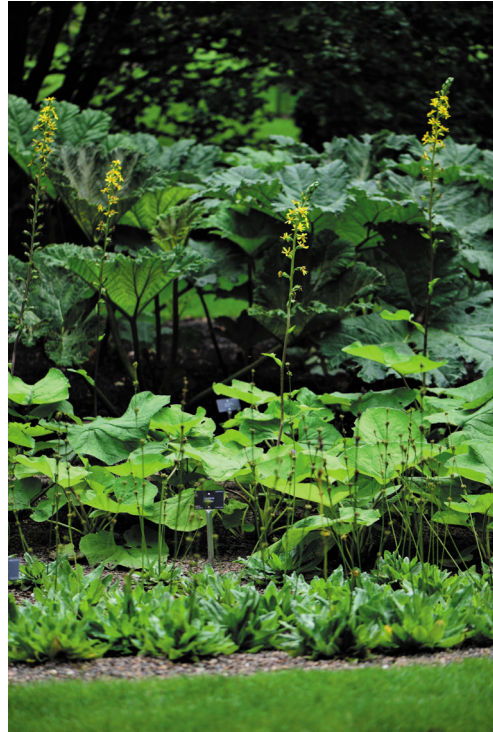
Fig. 16 A close-up view of the raingarden in summer 2019, showing the different layers of planting. Photo: Kirsty Wilson, RBGE.

The plants developed well in the months following planting. Fig. 15 shows the raingarden in the summer of 2019, with the planting having become well established. Fig. 16 was taken that same summer and shows the different layers of planting, ranging from those at the edge of the raingarden where soil conditions are drier, to those at the centre and far side where wetter conditions are expected. Figs 17 and 18 show the raingarden in spring 2020 after the mulch surrounding the raingarden had been renewed.

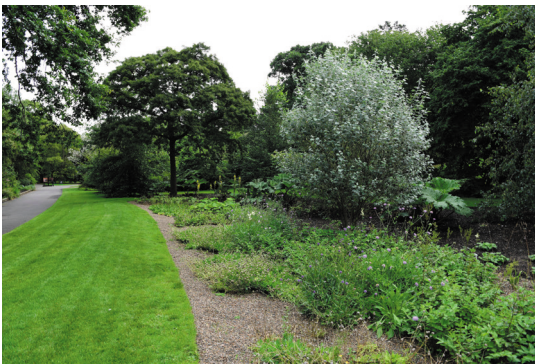
Fig. 15 A view of the raingarden from its west side in summer 2019, showing the planting now well established. Photo: Kirsty Wilson, RBGE.

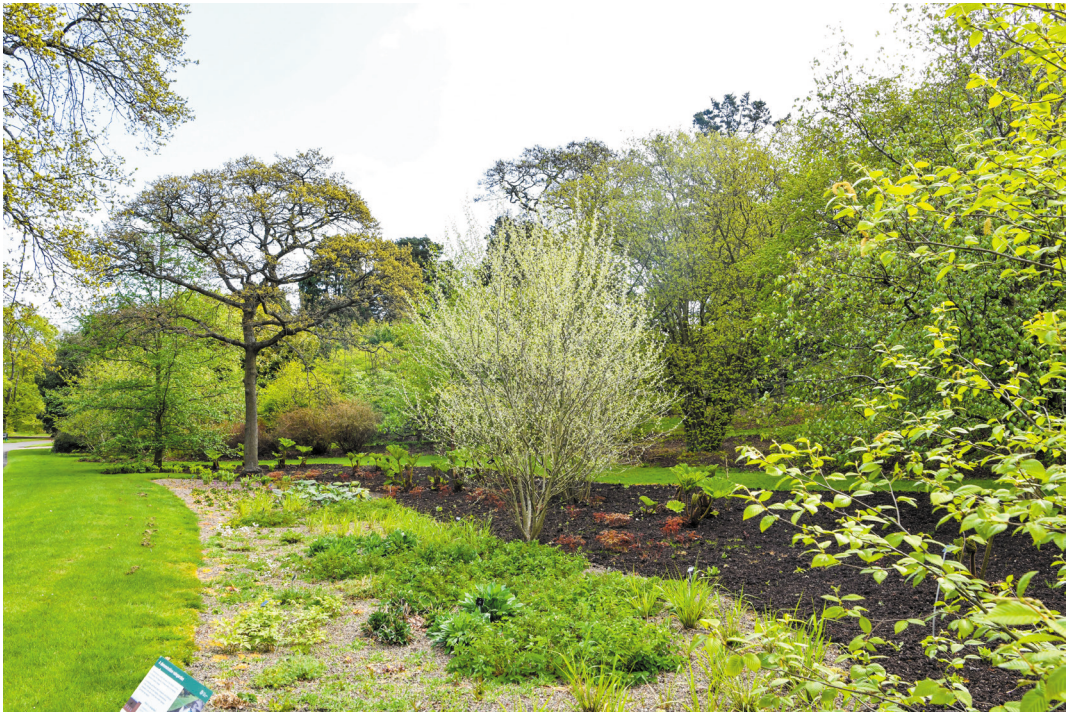
Fig. 17 The raingarden in spring 2020 following the addition of new mulch to the surrounding area. Photo: Kirsty Wilson, RBGE.

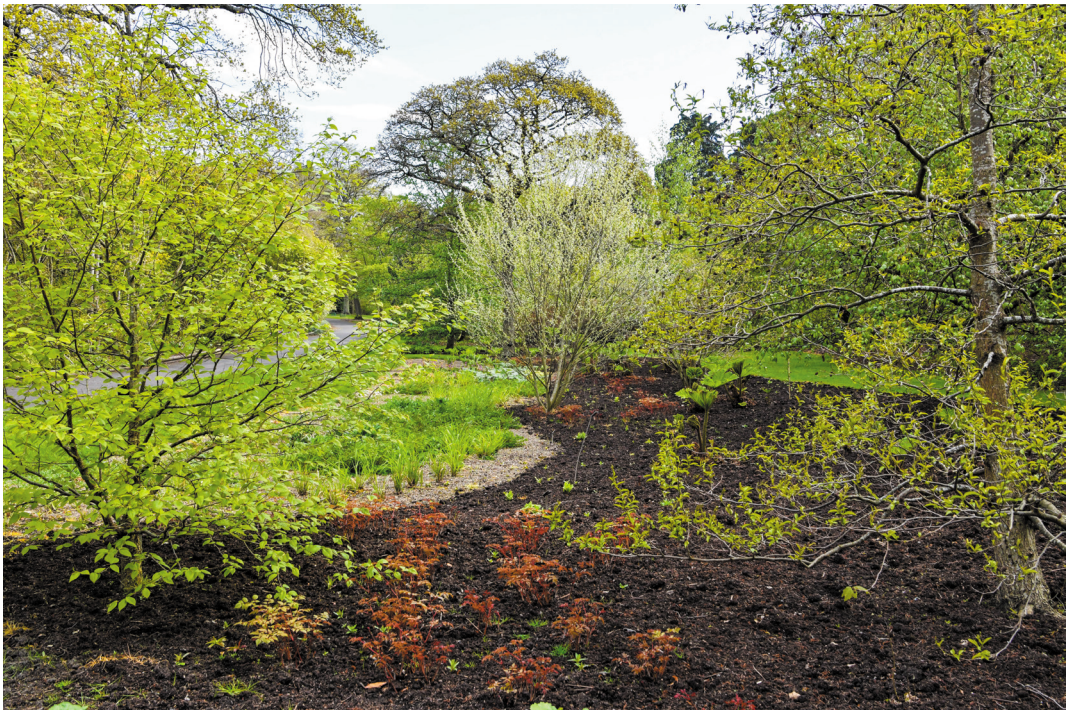
Fig. 18 New mulch added to the area surrounding the raingarden, taken in spring 2020. Photo: Kirsty Wilson, RBGE.
